North Queensland Study into Water Damage from Cyclones

Project partners: IAG and SUNCORP

Overview of study

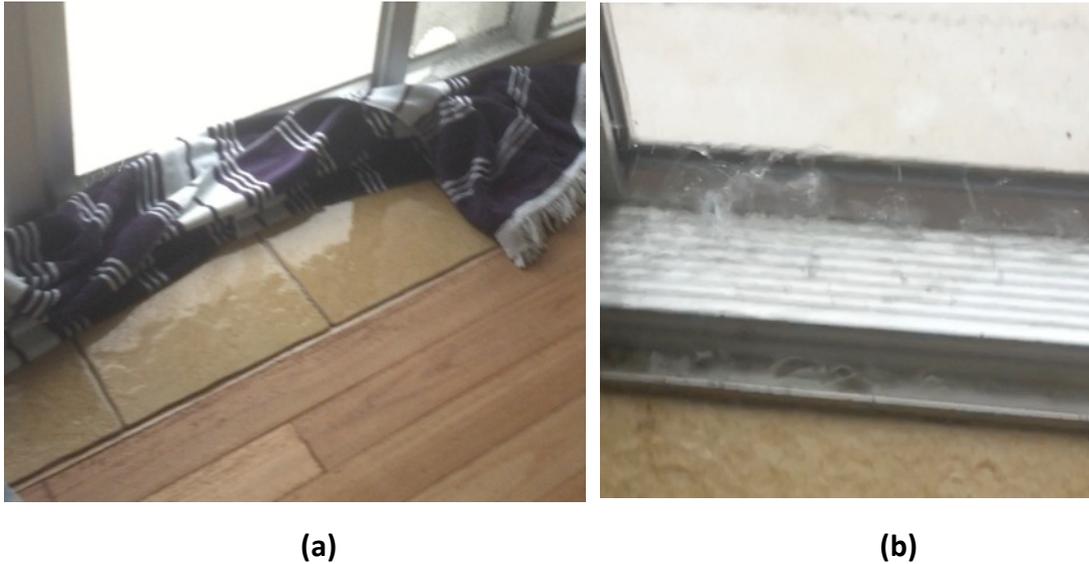
Videos taken during TC Debbie by residents showed that considerable volumes of water came through windows and sliding glass doors, under swinging doors, and through light fittings and ceilings. In many cases, the water entered buildings that had no damage to the building envelope. The rain caused damage to vulnerable elements such as plasterboard wall linings and ceilings; floor coverings; and personal belongings. In multistorey buildings, the rain percolated down through the building for a number of storeys below the original point of entry.

Figure 1 (a) Towels placed in front of large windward wall windows to control large amounts of water, and (b) water spaying into living room from under the door (CTS TR63)

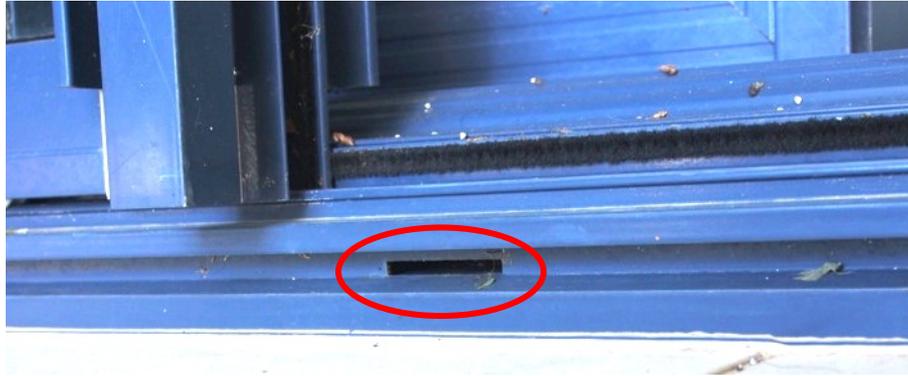
Weep holes in windows or glass sliding doors (Figure 3) are designed to allow condensation and minor leakage around seals to pass from the inside to the outside of the building. However, in high winds, differential pressure forces horizontally driven rain on windward walls through weep holes (i.e. in the opposite direction intended in design) and through other gaps in the building envelope.

Figure 3 Weep hole in glass sliding door frame

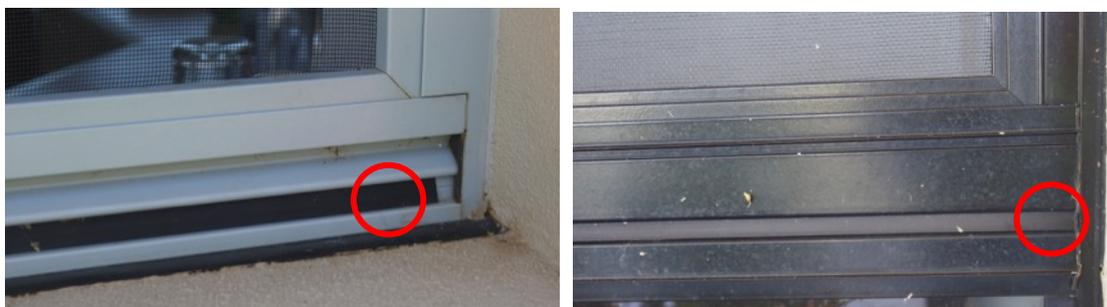
However some people mentioned, who were in either apartments or houses, they had no water or only a small amount of water enter through their sliding windows during TC Debbie. Typically, the windows without significant water ingress had weep holes that were covered by external rubber strips. Figure 3 (a) shows a window from a house and another in a larger apartment building with rubber seals over the weepholes that performed well. The windows and glass sliding doors in another apartment building, Figure 3 (b), had an external baffle that concealed the weepholes; only a small amount of water leaked through them. This door also had a step that would have assisted in reducing water into the unit from water that pooled on the balcony near the bottom of the door.

(a) Sliding windows with rubber flaps over weepholes

Figure 4 Windows and glass sliding doors that prevented wind-driven rain entering the building

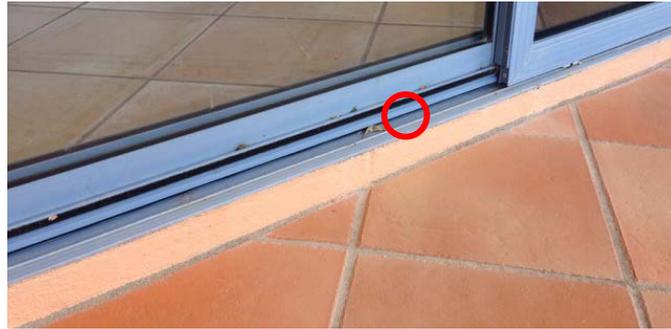
(b) Sliding glass doors with baffle that concealed the weepholes on an apartment balcony

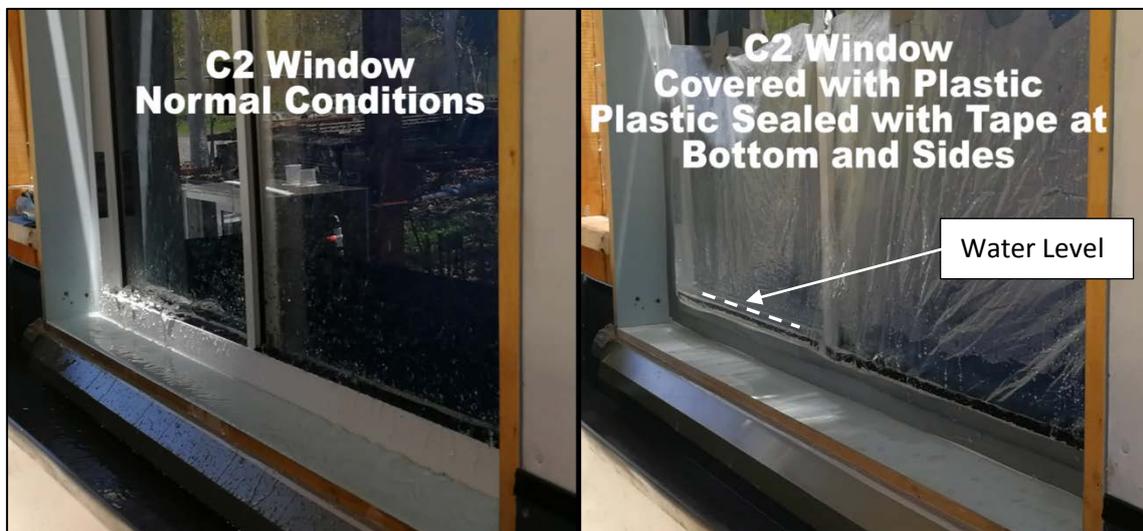
Various mitigation strategies such as taping over the weep holes were trialed. The only configuration that greatly reduced the amount of water ingress was by using a strip of plastic sheet taped on the inside of the window sill (i.e. outside of WDRS). This strip of thin plastic increased the height of the window sill, caught the water and allowed it to drain back out of the house via the weep holes. Figure 6 shows results side by side during a pressure peak of a fluctuating pressure trace. A significant amount of water is being pushed through the seals and over the sill of the window on the left side, while the water is constrained by the plastic lining on the right side. This was a similar result for the sliding door tests.

Figure 6 Side by side views of normal window and window with the Plastic sheet sill extension during a pressure peak

Simple measures such as storm shutters on the exterior or the plastic sheet sill extension on the inside face of the window can greatly reduce the amount of driven rain entering our homes.
