North Queensland Study into Water Damage from Cyclones

Project partners: IAG and SUNCORP

Overview of study

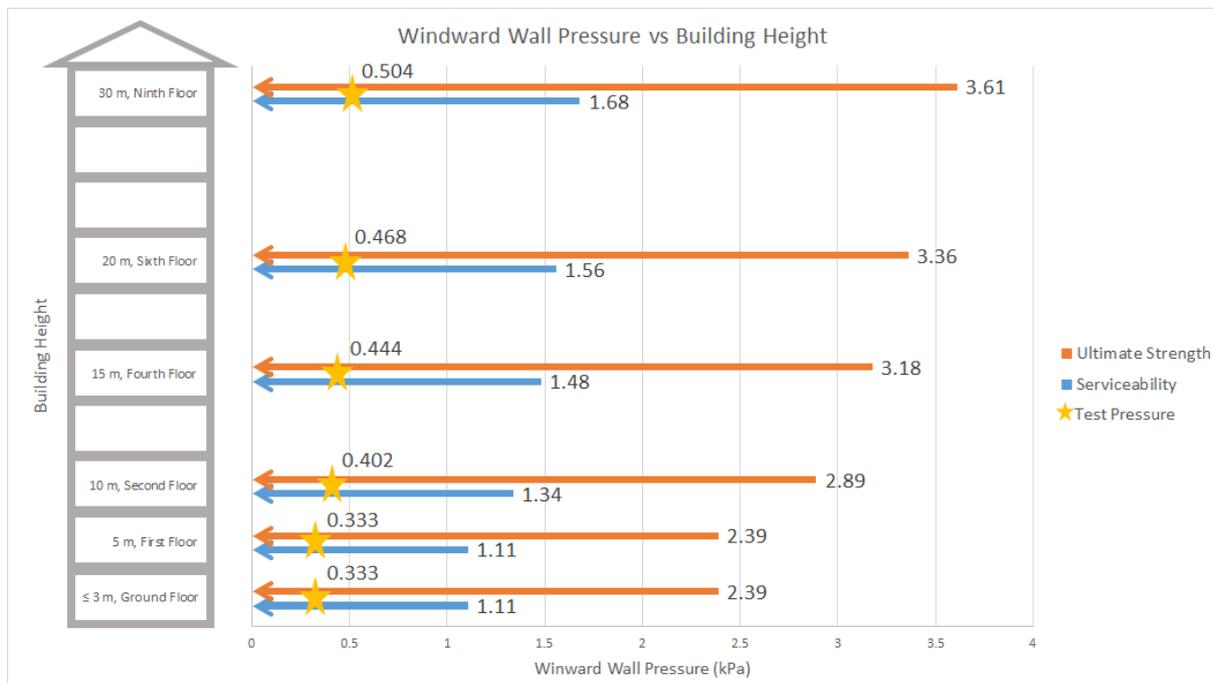
There is a large range of window sill designs in the marketplace; some window sealing and drainage systems are simple, while others are very complex. All windows must satisfy performance criteria in AS 2047 (Standards Australia, 2014), which includes a test to exclude water penetration at the prescribed test pressure. However, **this test pressure is only one-third of the serviceability design pressure (Serviceability design means that the building remains functional during and after this loading).**

Figure 2 Relationship between ultimate strength design pressure, serviceability design pressure and the test pressure for the Australian Standard water penetration test showing how small the test pressure is in relation to the Serviceability design.

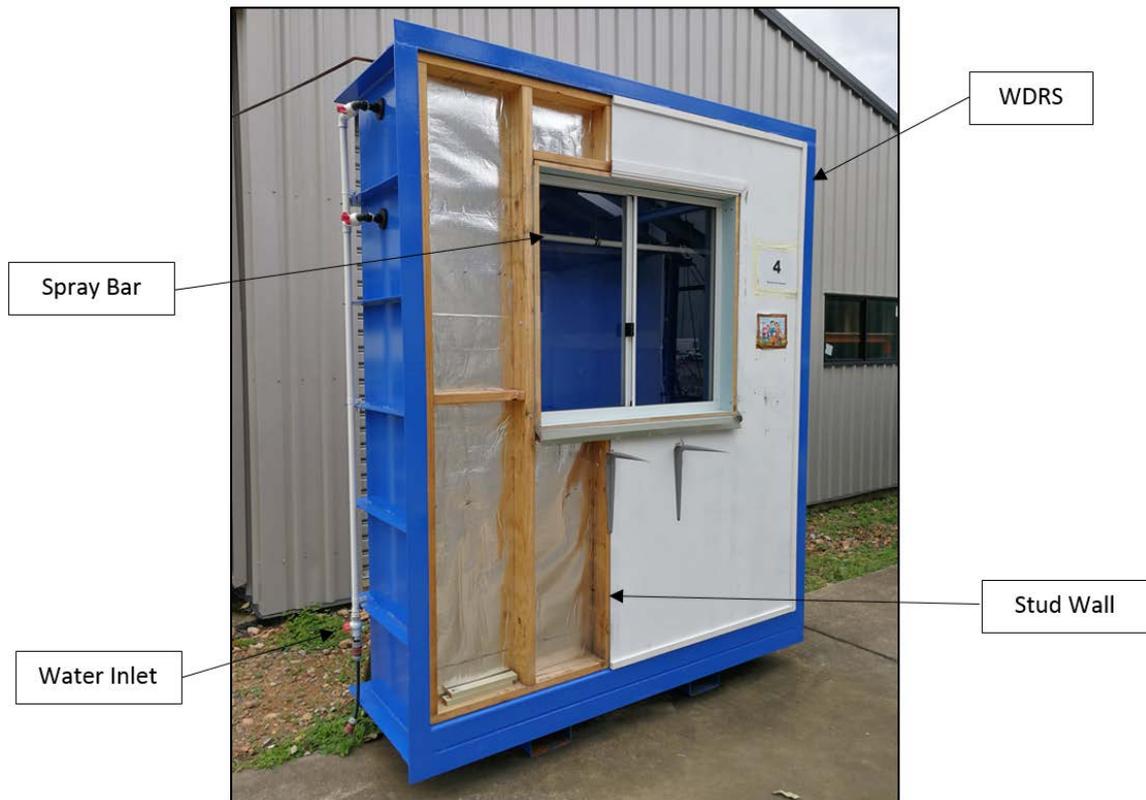
Figure 5 shows the WDRS with the wall sample including a window fitted to its open face.

During the testing, all the modern window and door specimens tested were compliant with the AS 2047 rain flow rate and static test pressure of approximately 300 Pa standard, and did not let uncontrolled water into the inside of the building. However, for the fluctuating pressures encountered during wind storms the windows and door leaked, a lot.

Figure 5: WDRS with Wall and Window Test Sample

Various mitigation strategies such as taping over the weep holes were trialed. The only configuration that greatly reduced the amount of water ingress was by using a strip of plastic sheet taped on the inside of the window sill (i.e. outside of WDRS). This strip of thin plastic increased the height of the window sill, caught the water and allowed it to drain back out of the house via the weep holes. Figure 6 shows results side by side during a pressure peak of a fluctuating pressure trace. A significant amount of water is being pushed through the seals and over the sill of the window on the left side, while the water is constrained by the plastic lining on the right side. This was a similar result for the sliding door tests.
